GEOLOGICAL NOTE

Tsunamigenic, earthquake-triggered rock slope failures during the April 21, 2007 Aisén earthquake, southern Chile (45.5°S)

Sergio A. Sepúlveda¹, Alejandra Serey¹

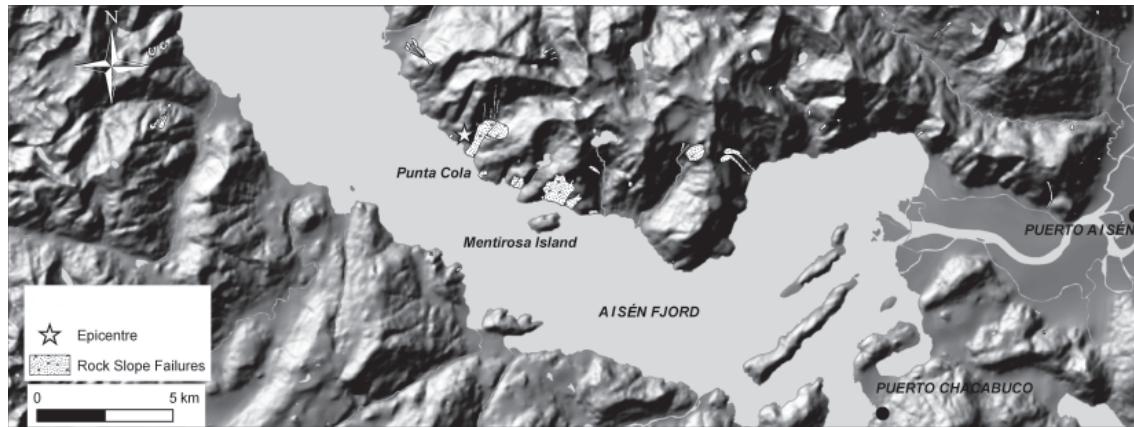
FIG. 2. Digital terrain model of the epicentral area represented as a shaded relief map, showing the approximate location of the April 21, 2007 earthquake epicentre by the Seismological Survey (Barrientos, 2008, personal communication) and the main mapped rock slope failures along the fjord shores and nearby areas.

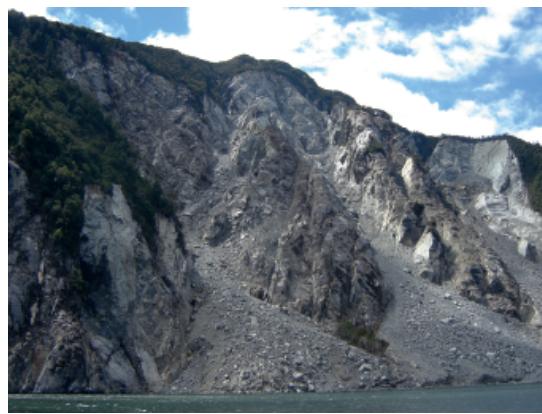
The largest and most significant tsunamigenic landslides (Glossary) were disrupted rock slides that rapidly evolved to rock avalanches. This kind of failure was restricted to high and steep slopes along the fjord shore and close to it in narrow lateral valleys (Fig. 2). The rock slides (Glossary) were characterized by massive, mainly translational movements of rock that were rapidly disintegrated. In many cases, the slides did not show significant structural control by joint surfaces dipping out of the slopes, but tended to occur in highly fractured rock around shear or fault zones, where the geotechnical quality of the rock mass is reduced. Their thicknesses varied in general between 5 and 15 m, which can be considered as shallow given the slope heights where they occurred, which vary between *ca.* 200 and 1000 m. The rock slides mainly occurred along the northern fjord shore, the most significant of which are a landslide complex in front of Mentirosa Island and a large slide in a ravine next to Punta Cola (Figs. 2, 3 and 4). The estimated volumes of these landslides are 7 and 12 millions of cubic metres, respectively (Clavero *et al.*, 2008). A less volumetric shallow soil and rock slide in the southern shore also generated a smaller tsunami southwest of Mentirosa Island (Clavero *et al.*, 2008; Naranjo *et al.*, 2009, this volume).

The disrupted nature and high kinetic energy of the largest rock slides allowed them to transform into rock avalanches (see Glossary). The slides next to Mentirosa Island discharged directly into the fjord water, thus it is not clear whether they can be regarded as avalanches. On the other hand, the large rock slide in the ravine close to Punta Cola stripped vegetation from the opposite slope as it continued downstream, with marks indicating heights of over 20 m (Fig. 4). These marks and the deposits of more than 10 m thick along the gully, suggest a rock avalanche mechanism. The avalanche traveled for about 1 km before it reached the fjord.

FIG. 3. Rock slide complex on the northern shore of Aisén Fjord, in front of Mentirosa Island (location in figure 2). Three main rock slides that stripped the vegetation out can be observed along with debris cones that form the non-submerged part of the deposit of disintegrated rock.

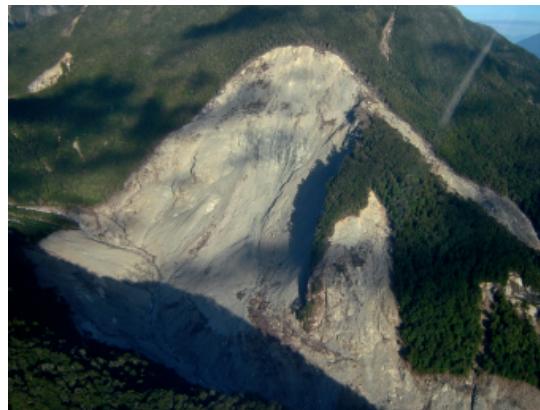
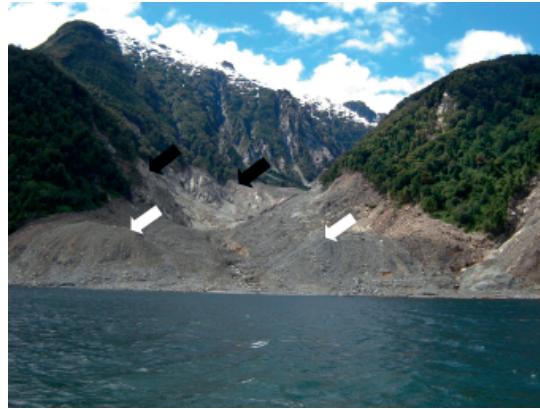
FIG. 4. Rock slide and avalanche in a ravine in the Punta Cola area (location in figure 2). The upper photo shows the ~12 million m³ rock slide on the eastern ravine slope. The bottom photo shows the erosion marks (black arrows) and deposits of the rock avalanche (white arrows) along the ravine.

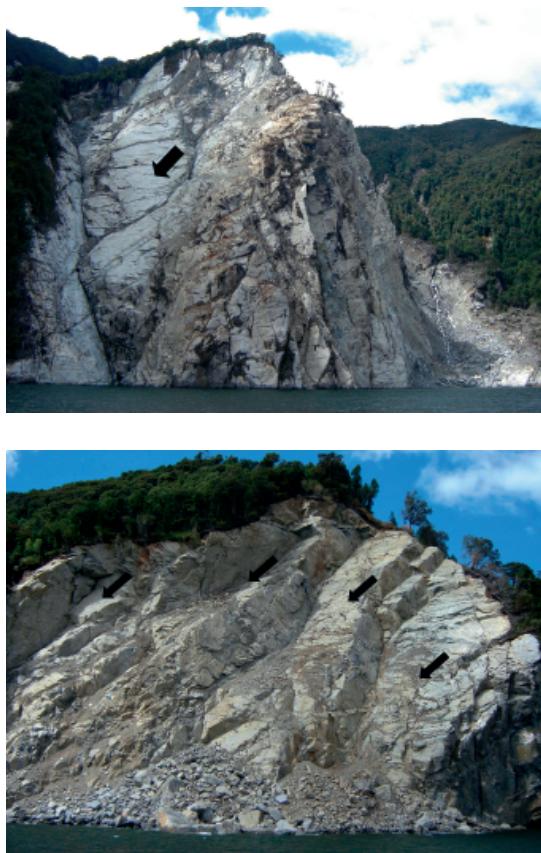
The second failure mode found in rock slope failures are rock block slides (Glossary, Fig. 5) that in many cases transformed into rock falls due to the high steepness of the fjord coastal bluffs and some glacial valley slopes inland. Some rock falls (Glossary) could also have been induced by tensile failure along subvertical cracks and joints. Mobilized volumes are highly variable, and can reach up to dozens of thousands of cubic metres.

FIG. 5. Rock block slides and falls on the northern fjord shore. Arrows show the sliding surfaces composed of pre-existing joints.
